NOT ALL TILE

IS CREATED EQUAL

LUDOWICI
ROOF TILE

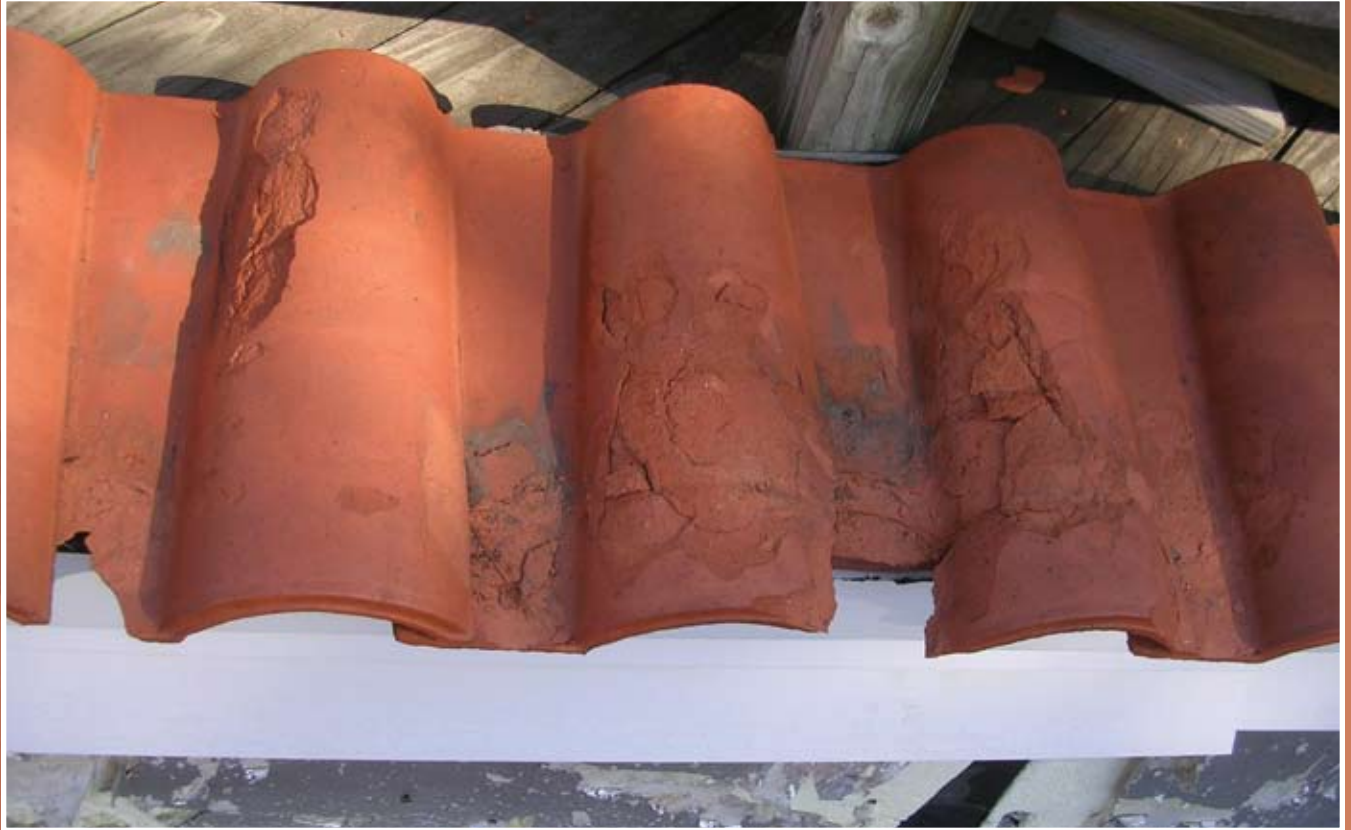
This tile on a New York school was imported from Italy and failed after 8 years.

NORTHEASTERN FREEZE/THAW CONDITIONS ARE TOO HARSH FOR IMPORTED TILES.

Because imported tiles usually have between 4% and 12% moisture absorption. In the winter the moisture in the tile freezes and thaws and puts a huge mechanical constraint on the structure of the tile. After a number of freeze/thaw cycles, the tile ends up cracking and spalling leaving an unsightly result on the roof.

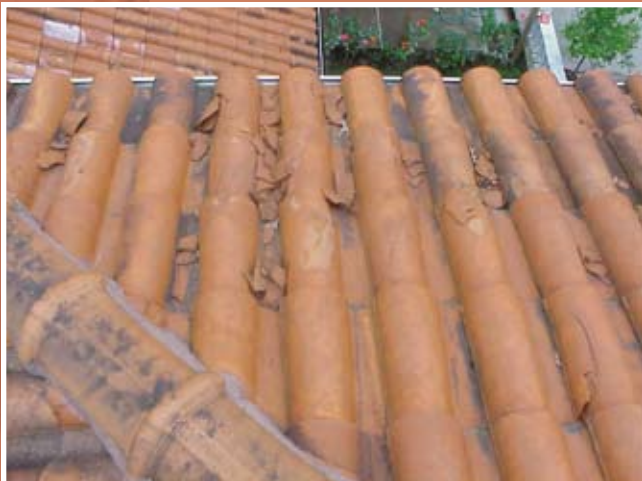
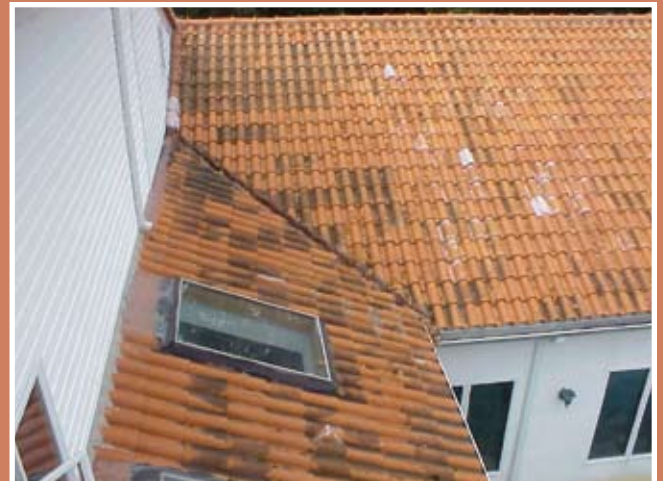
This New Jersey home features a clay tile from South America. The roof spalled after only three winters.

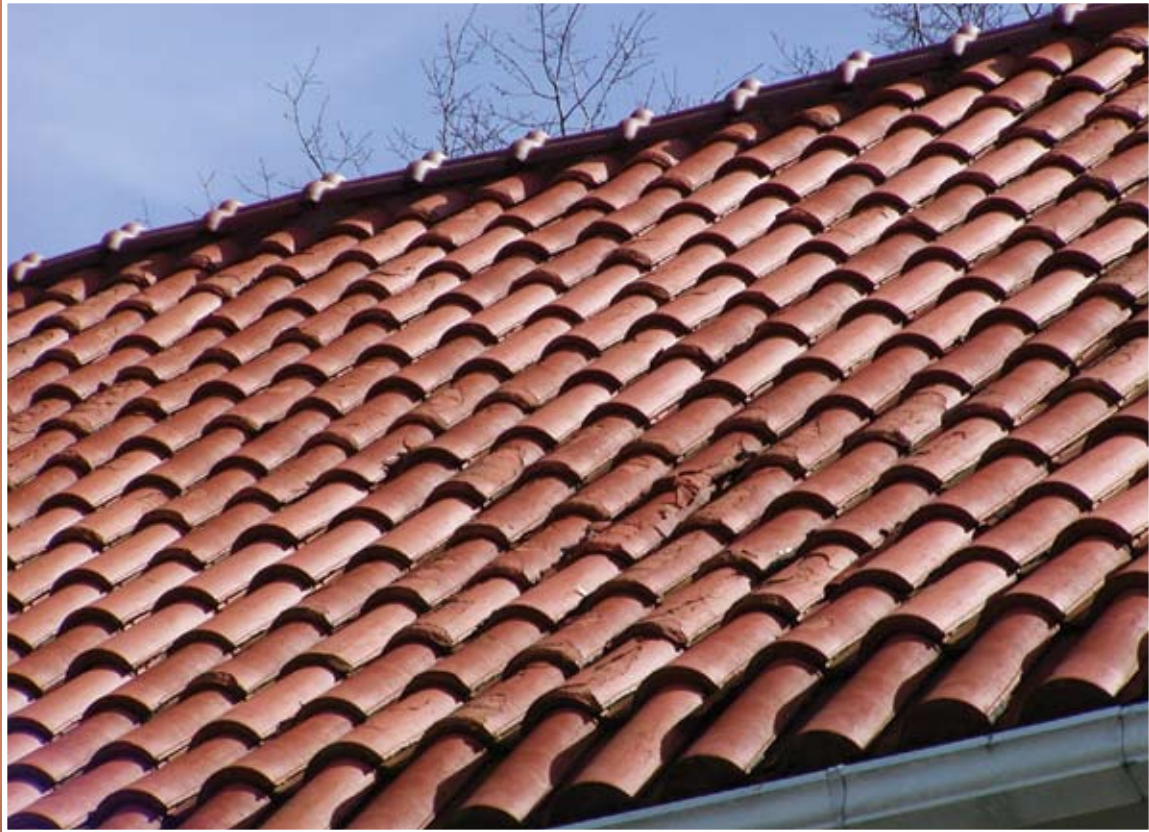
Half of this New York roof was installed with an Italian tile that failed after 12 years...

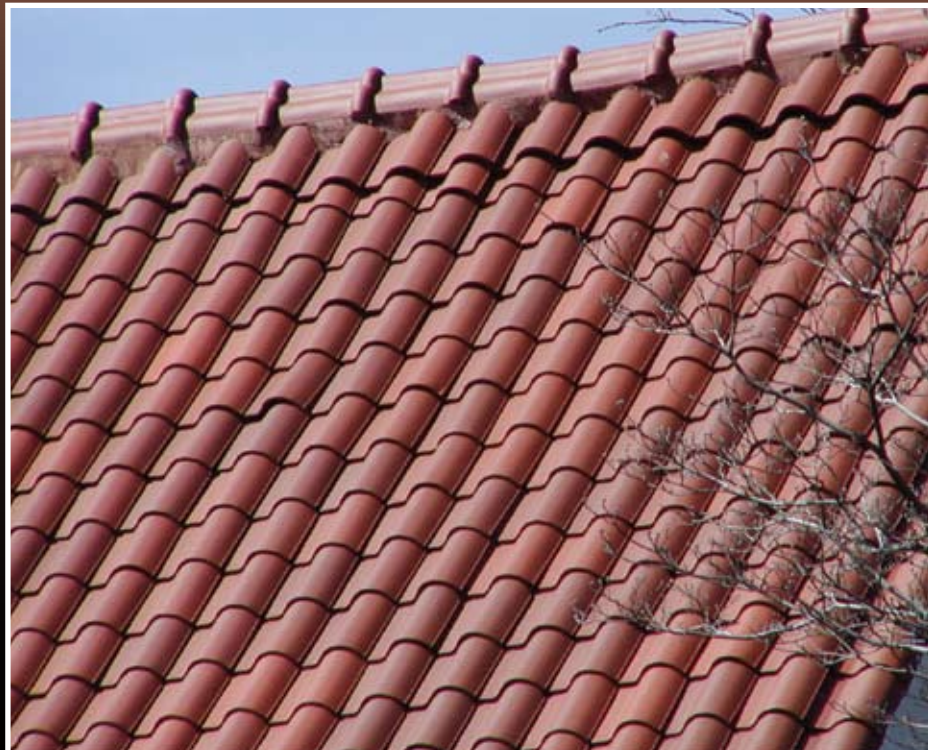
... What happened to the other half of this roof? Nothing, it was installed with Ludowici tile, and it will look just as good for 75 years – guaranteed.

- Because Ludowici tiles have less than 1% moisture absorption, and they are absolutely not sensitive to freeze/thaw cycles. No other manufacturer can make this claim.
- Because you can see Ludowici tiles around that have performed more than 75 years. The Plaza hotel roof was just redone, and the last installation with Ludowici tile dates back to 1920.
- Because Ludowici offers a 75-year warranty and is a 120 year-old company based in the United States.
